# INDOOR AIR QUALITY ASSESSMENT

**Lowell Juvenile Court  
291 Summer Street  
Lowell, Massachusetts**

Prepared by:  
Massachusetts Department of Public Health  
Bureau of Environmental Health Assessment  
July, 2001

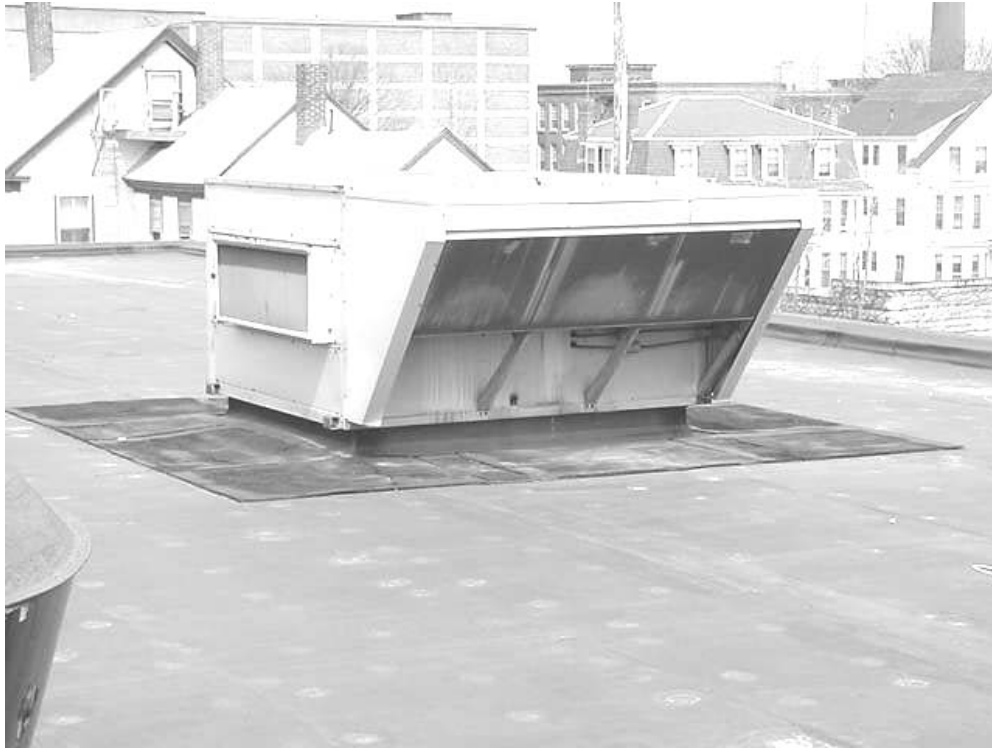
**Picture 2**

It can be seen from the tables that carbon dioxide levels were above 800 parts per million parts of air [ppm] in seven of twelve areas sampled, which is indicative of inadequate fresh air supply in these areas. A heating, ventilation and air conditioning (HVAC) system provides ventilation. Fresh air is provided by two rooftop-mounted air-handling units (AHUs) (see Picture 2). Air is distributed by ducted, ceiling vents located throughout the building (see Picture 3). The LJC is divided into two HVAC zones divided in the center of the building. The zones are each controlled by thermostats (see Picture 4). These types of thermostats usually have settings of “on” and “automatic” and are typically set to the “automatic” setting. The automatic setting on the thermostat activates the HVAC system at a preset temperature. Once a preset temperature is reached by the thermostat, the HVAC system is deactivated. Therefore no mechanical ventilation is provided until the thermostat re-activates the system. The system was not operating during the assessment, which indicates that it was in the off-cycle or deactivated. Several air diffusers were sealed with plastic sheeting and/or cardboard (see Picture 5 & 6). Occupants stated that these diffusers have been obstructed since the LJC occupied the

**One of Two Rooftop AHUs**

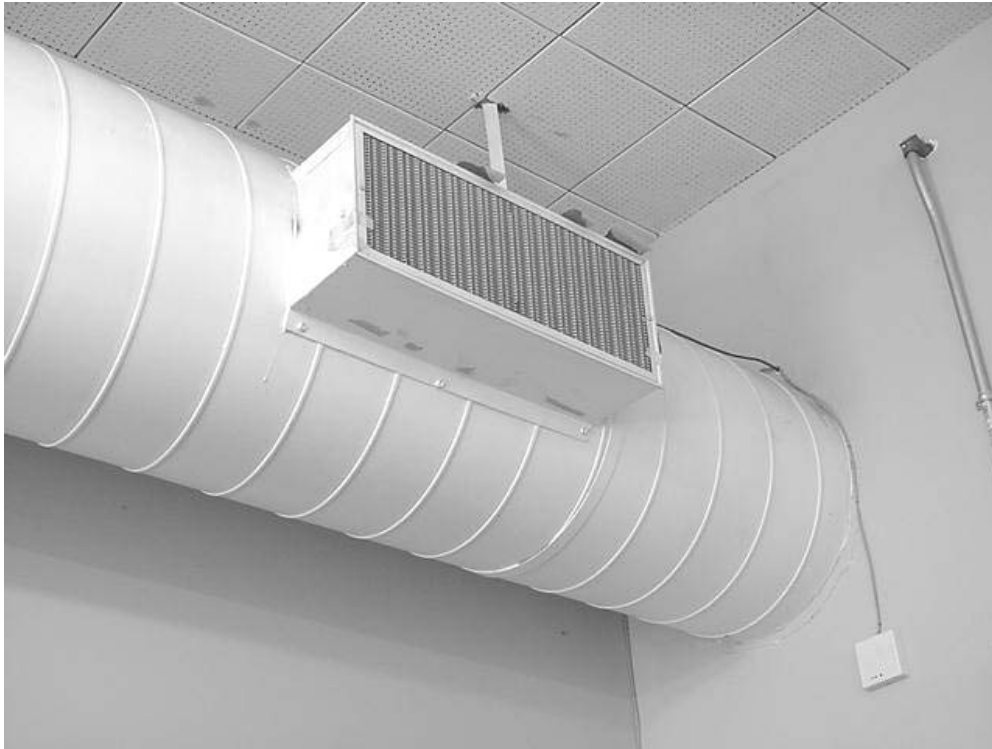
**Picture 3**

**Fresh Air Diffuser**

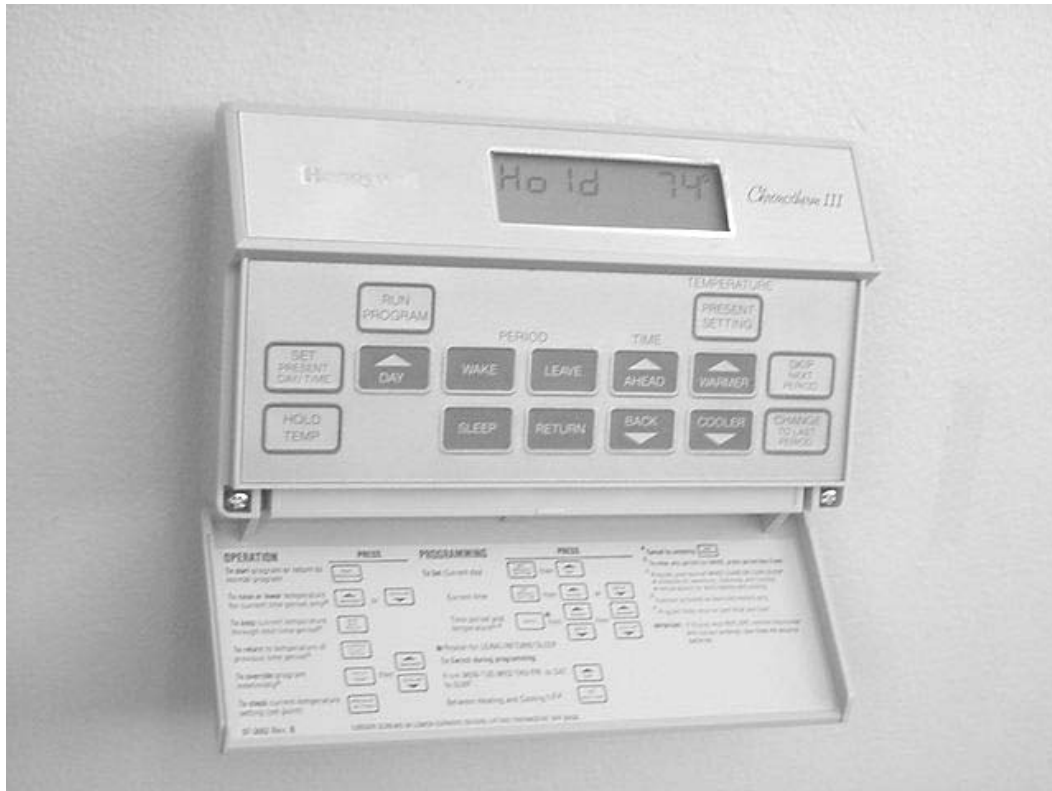
Picture 4

Thermostat Controlling HVAC System

1. To maximize air exchange, the BEHA recommends that the ventilation system operate to continuously supply fresh air during business hours. Contact HVAC maintenance representative (Honeywell, Inc.) to determine if thermostats can be set to operate the HVAC system continuously during periods of occupancy.
2. Inspect rooftop AHUs to ensure fresh air intake louvers are operable. Change filters for AHU equipment as per the manufacturer's instructions or more frequently if needed. Examine AHUs periodically for maintenance and function, repair/replace parts as necessary.
3. Consider having the mechanical fresh air supply and exhaust balanced by an HVAC engineer. Increase the percentage of fresh air if necessary.
4. Remove all blockages from air diffusers to ensure adequate airflow.
5. Examine the feasibility of providing mechanical exhaust ventilation.

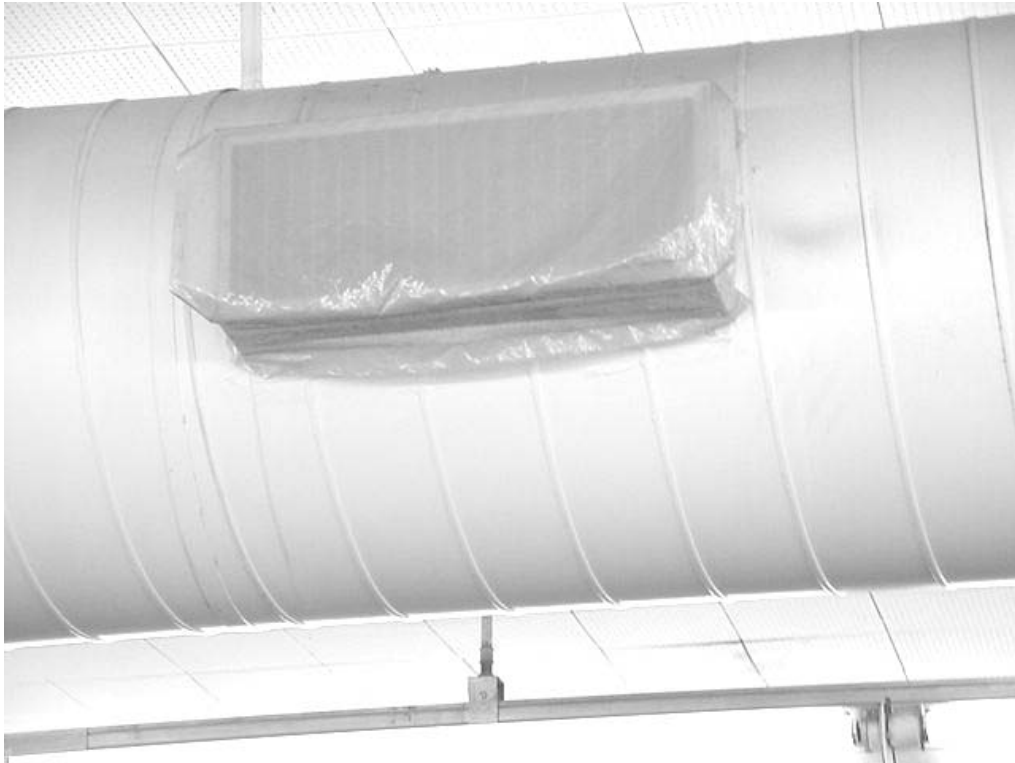
**Picture 5**

building (approximately 2 years ago). Alterations of the system such as these can interfere with proper airflow and balancing, resulting in the creation of uneven heating/cooling conditions in other areas.

Although the temperature in a number of areas measured on the day of the assessment were within BEHA comfort guidelines, occupants expressed a number of complaints of uneven heating and cooling. As mentioned previously, diffusers distributing air to workstations throughout the space were obstructed, which can prevent proper airflow and circulation and subsequently lead to comfort complaints.

**Fresh Air Diffuser Sealed With Plastic Sheeting**

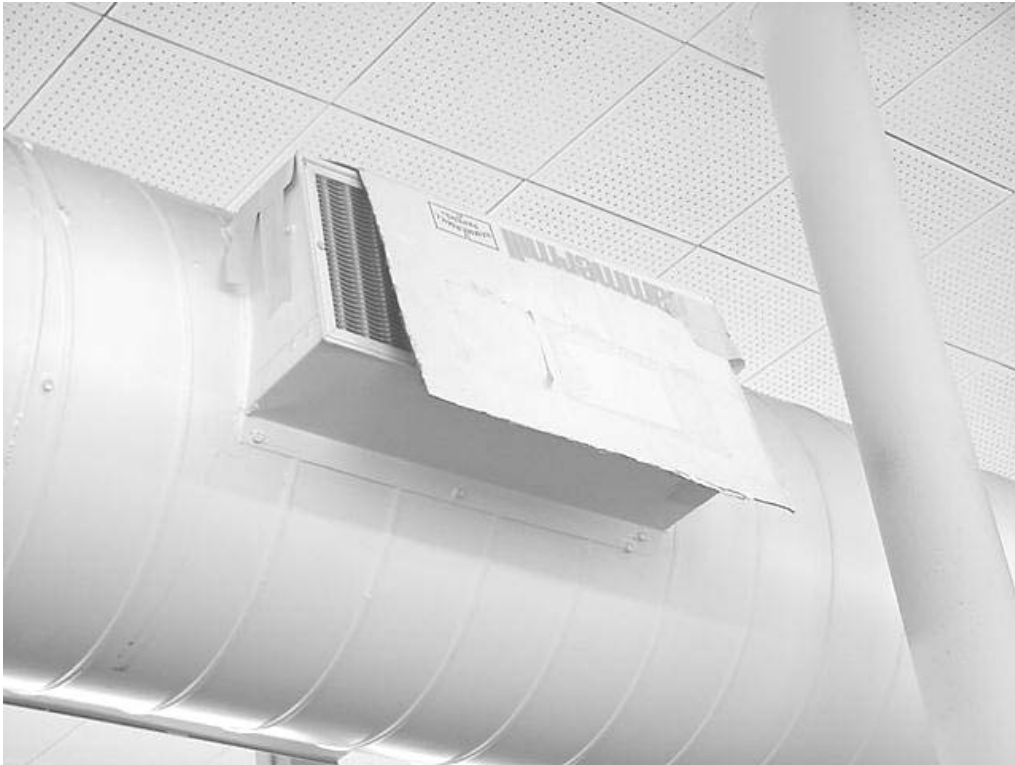
**Picture 6**

**Fresh Air Diffuser Obstructed by Cardboard**

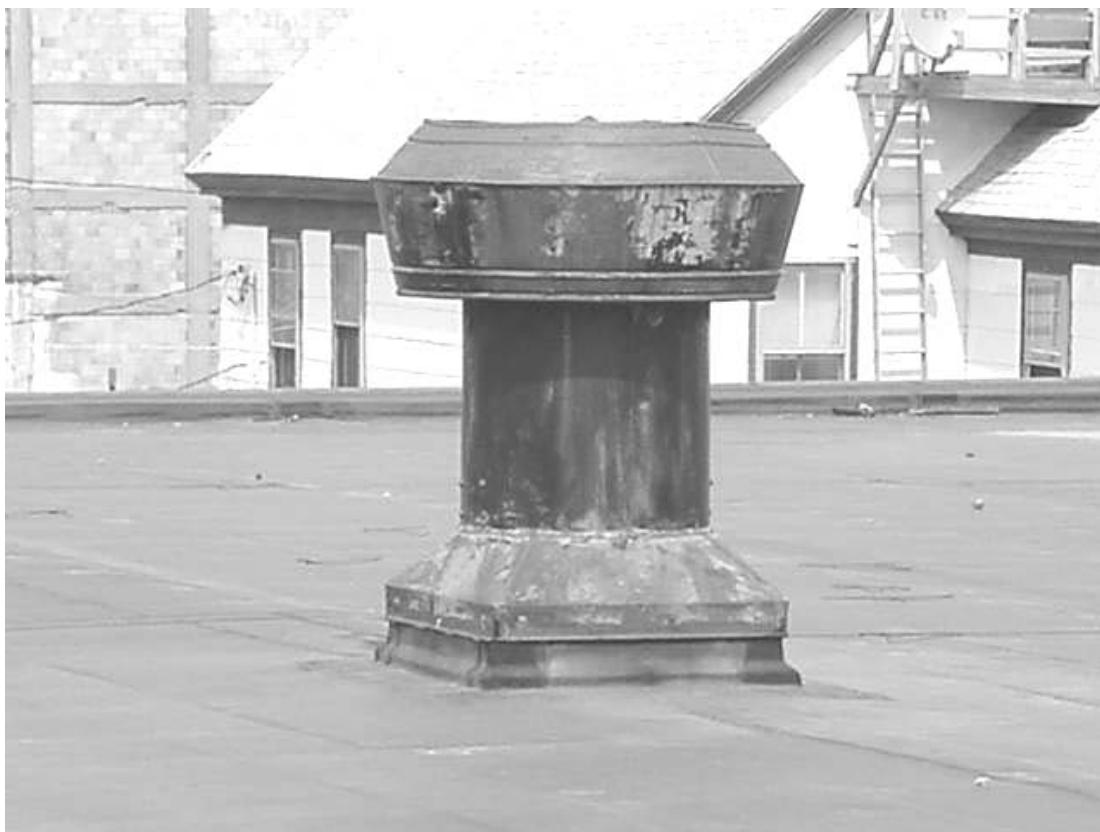
**Picture 7**

Exhaust ventilation is provided by three passive, non-mechanical rooftop vents (see Picture 7). This type of ventilation system relies on positive pressure created by the HVAC system to force air out the passive exhaust vents. As rooftop AHUs operate, air pressure increases as additional fresh air is introduced to pressurize the interior of the building (called positive pressure). As positive pressure increases, air is forced out through openings in the ceiling (see Picture 8) and out the rooftop exhaust vents. The design of the vents requires that exterior doors and windows remain closed to the extent practical in order to maintain positive pressure. Reports of drafts and occasional precipitation from these passive vents were reported by building occupants. Without a mechanical system, these vents may not function adequately to provide exhaust ventilation and be a source of cold air during winter months. In order to have vents operate as designed, doors and windows must remain closed.

**Passive Rooftop Exhaust Vent (One of Three)**

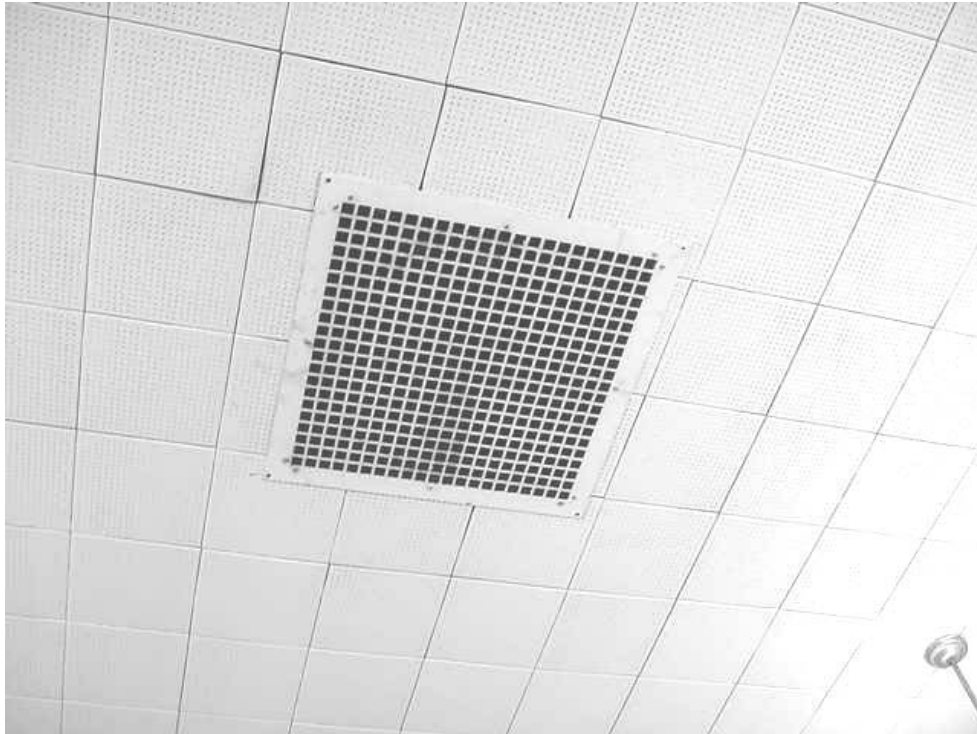
**Picture 8**

**Passive Exhaust Grill**

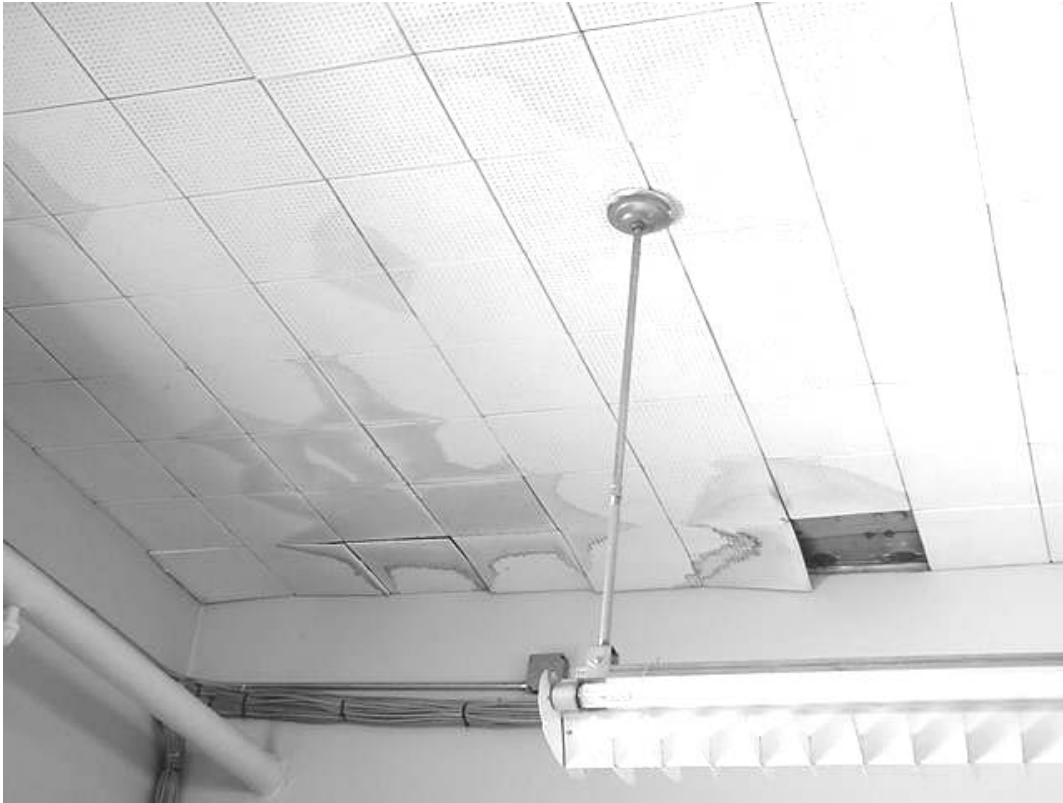
**Picture 9**

Several areas contained water-stained ceiling tiles (see Picture 9), which are evidence of historic roof or plumbing leaks. Water-damaged ceiling tiles can provide a source of microbial growth and should be replaced after a water leak is repaired.

**Water-Damaged Ceiling Tiles**

7. Remove tree and/or plant growths against the building.
8. Repair any existing water leaks and replace any water-stained ceiling tiles. Examine the areas above these tiles for mold growth. Disinfect areas of water leaks with an appropriate antimicrobial as needed.

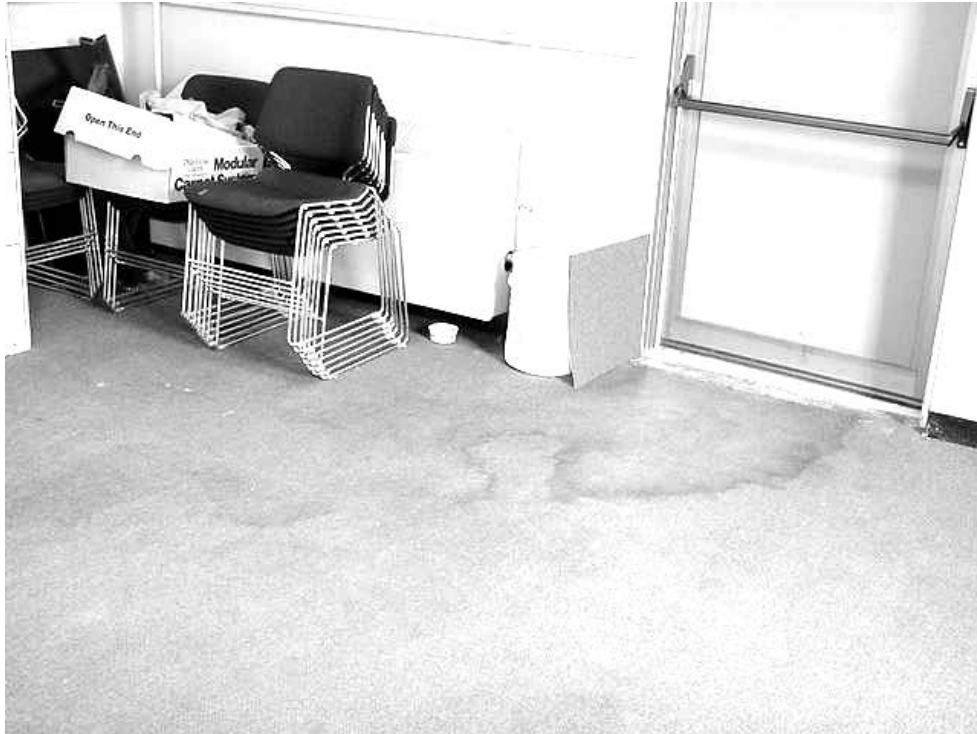
**Picture 10**

Flooring of the LJC is covered throughout with square carpet tiles. Water stains were noted on carpeting in front of the exterior door that exits to the side parking lot (see Picture 10). The most likely source of water is through spaces around the exterior door.

**Water-Damaged Carpeting Near Exterior Door to Side Parking Lot**

9. Report any roof leaks or other signs of water penetration to building owner/manager for prompt remediation.
10. Seal exterior door to side parking lot with weather-stripping to prevent water penetration and subsequent water damage to carpeting.

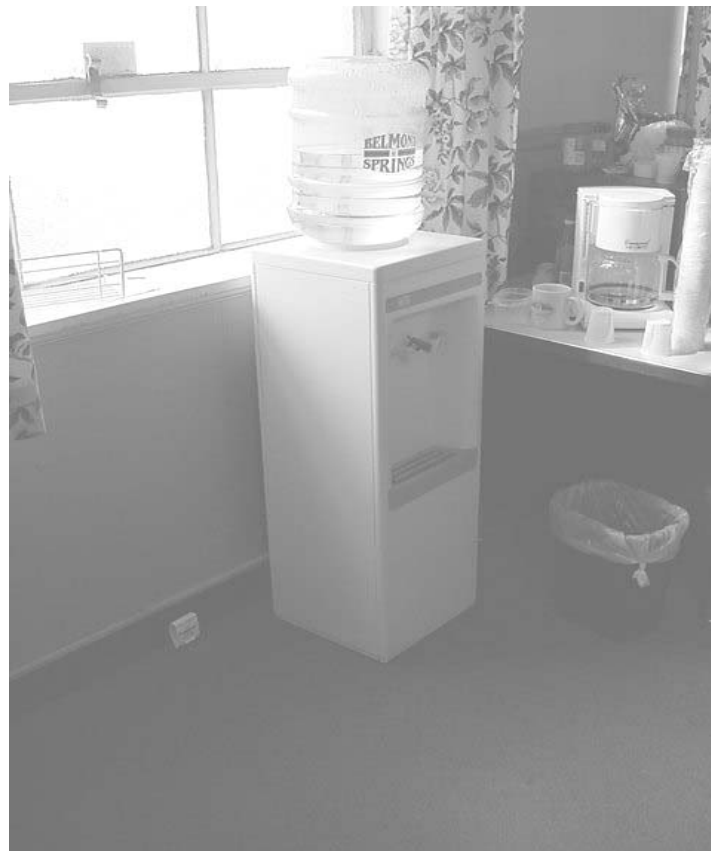
**Picture 11**

The break room had a water cooler installed over carpeting (see Picture 11). Water spillage or overflow of cooler catch basins can result in the wetting of the carpet. The American Conference of Governmental Industrial Hygienists (ACGIH) recommends that carpeting be dried with fans and heating within 24 hours of becoming wet (ACGIH, 1989). If carpets are not dried within this time frame, mold growth may occur.

**Water Cooler on Carpet**

13. Place rubber/plastic matting beneath water cooler to prevent water damage to carpeting.
14. Remove container of oil in basement, empty containers of hazardous materials in a manner consistent with environmental statutes and regulations.
15. Increase/improve carpet cleaning.

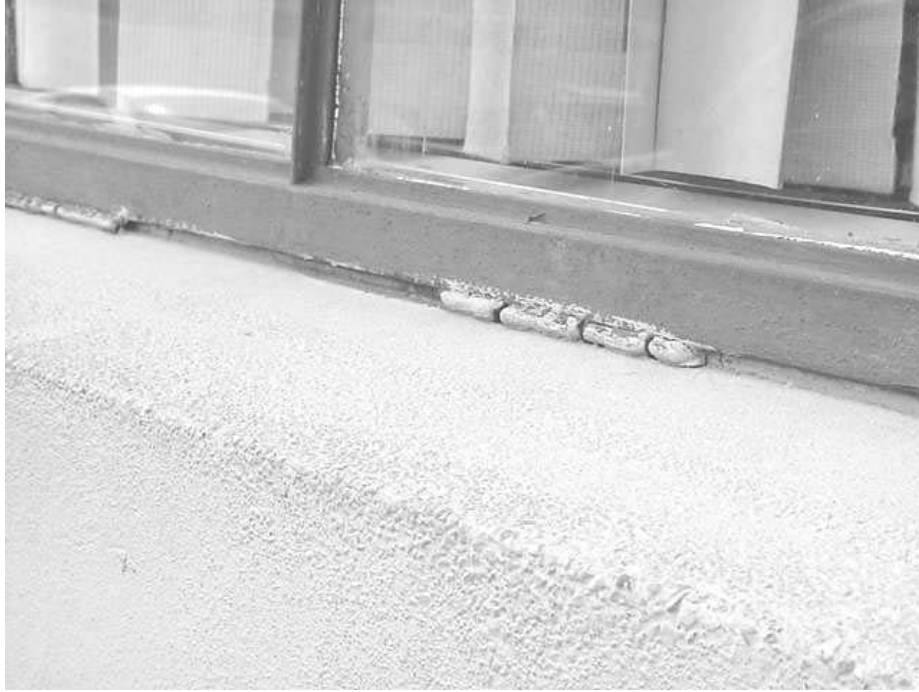
**Picture 12**

Caulking around window frames was in a crumbling/damaged condition (see Pictures 12 & 13). Efflorescence (i.e., mineral deposits) and peeling paint were observed on the interior walls of the building around windows (see Picture 14). Efflorescence is a characteristic sign of water intrusion. As moisture penetrates and works its way through mortar around brick and other building materials (e.g., plaster, wallboard) it leaves behind these characteristic mineral deposits. This condition indicates that water from the exterior is penetrating into the building. In addition, several windowpanes were also broken. Water penetration through broken windowpanes and frames can lead to mold growth under certain conditions. Replacement of broken windows and repairs of window leaks are necessary to prevent further water penetration.

**Missing/Damaged Exterior Window Caulking**

12. Repair/replace loose/broken windowpanes and missing or damaged window caulking building-wide to prevent water penetration through window frames.

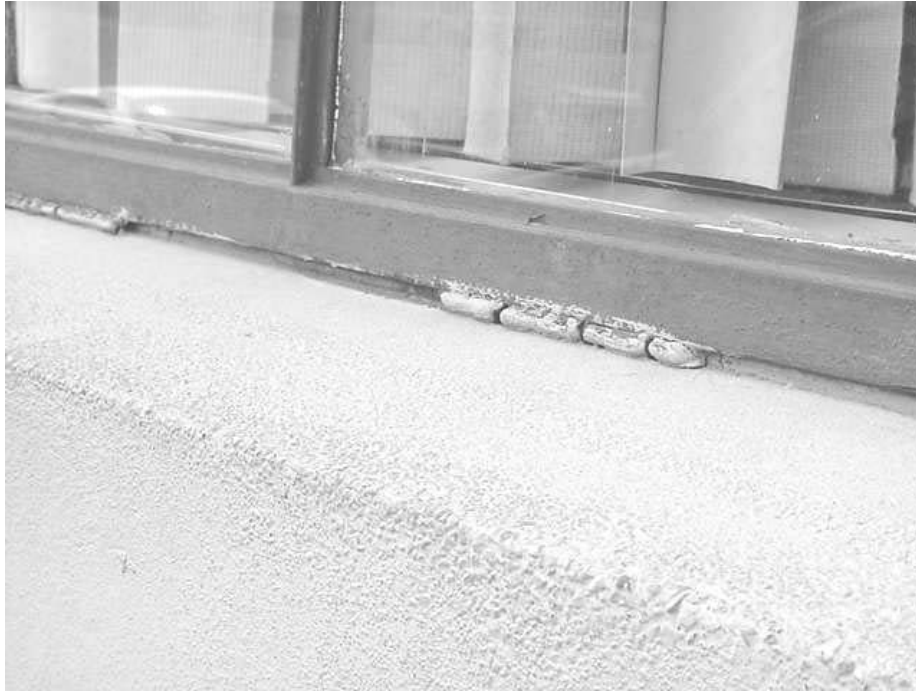
**Picture 13**

**Spaces around Exterior Window Frames**

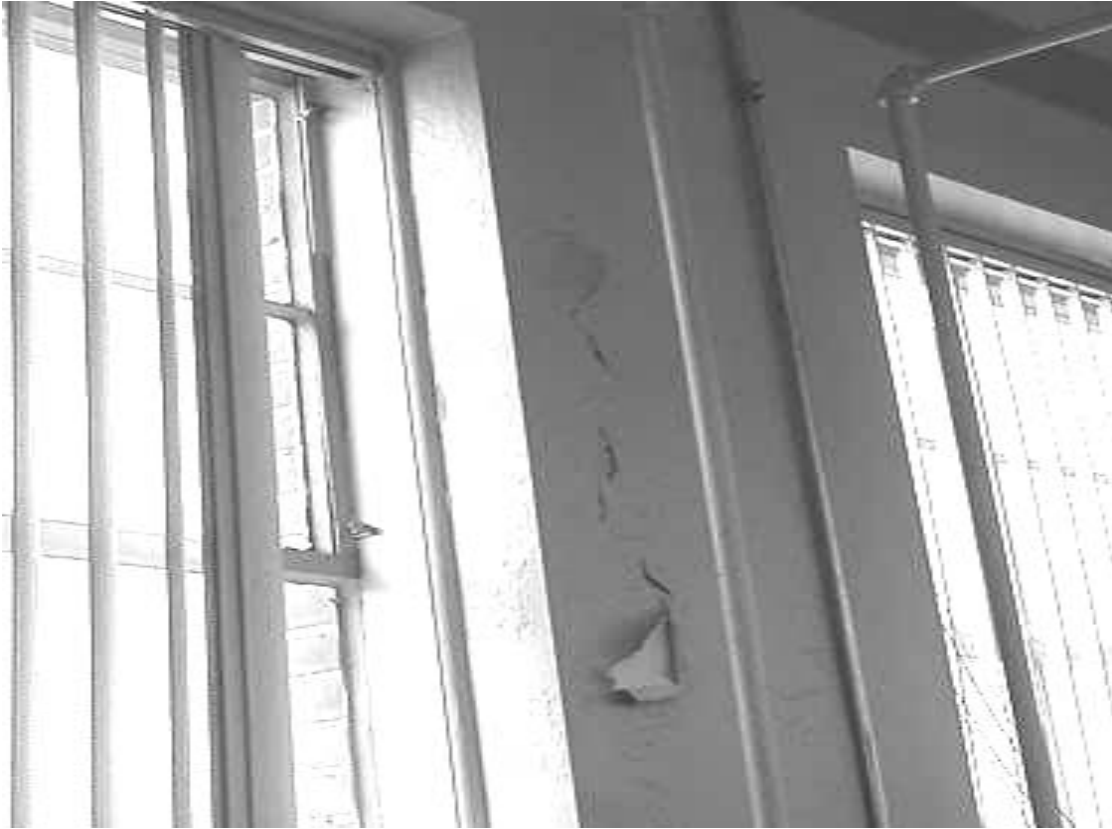
**Picture 14**

**Water-Damage/Peeling Paint on Interior Wall**

11. Consider having exterior brick repointed and waterproofed to prevent further water intrusion. Repair/replace water damaged plaster. Examine surrounding non-porous areas for mold growth and disinfect with an appropriate antimicrobial if necessary.

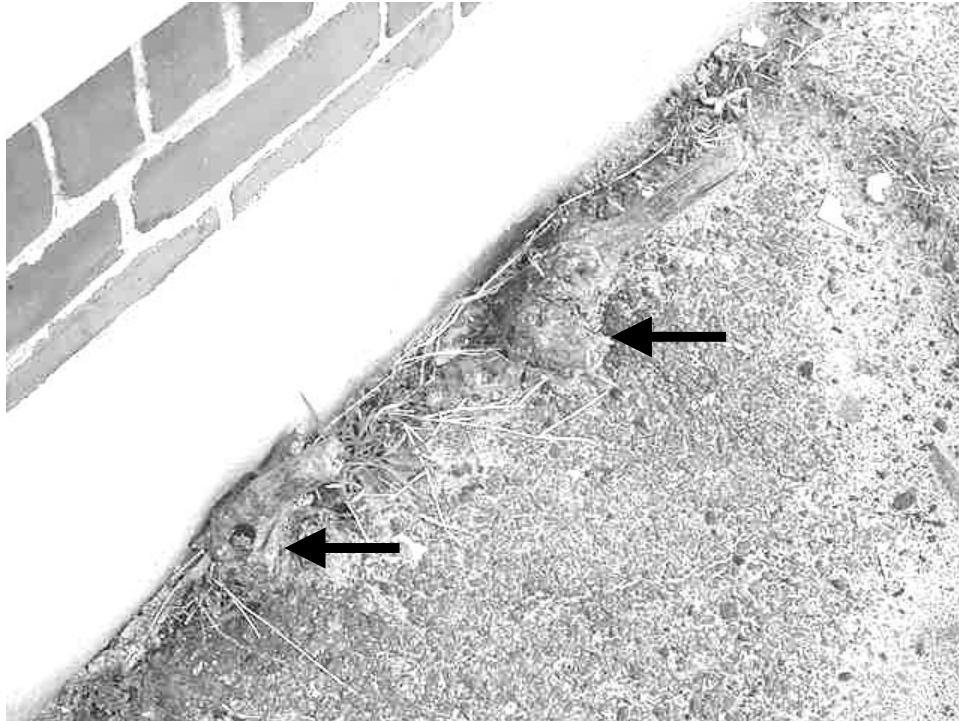
**Picture 15**

Also noted along the perimeter of the building were trees/stumps and other plants growing in the tarmac/exterior wall junction (see Picture 15). The growth of roots against the exterior walls of the building can bring moisture in contact with wall brick and eventually lead to cracks and/or fissures in the foundation below ground level. This problem can serve to breach the integrity of the building envelope and therefore could serve as a source of water penetration.

**Plant Growth along Exterior Wall/Tarmac Arrows Indicate Small Tree Stumps**

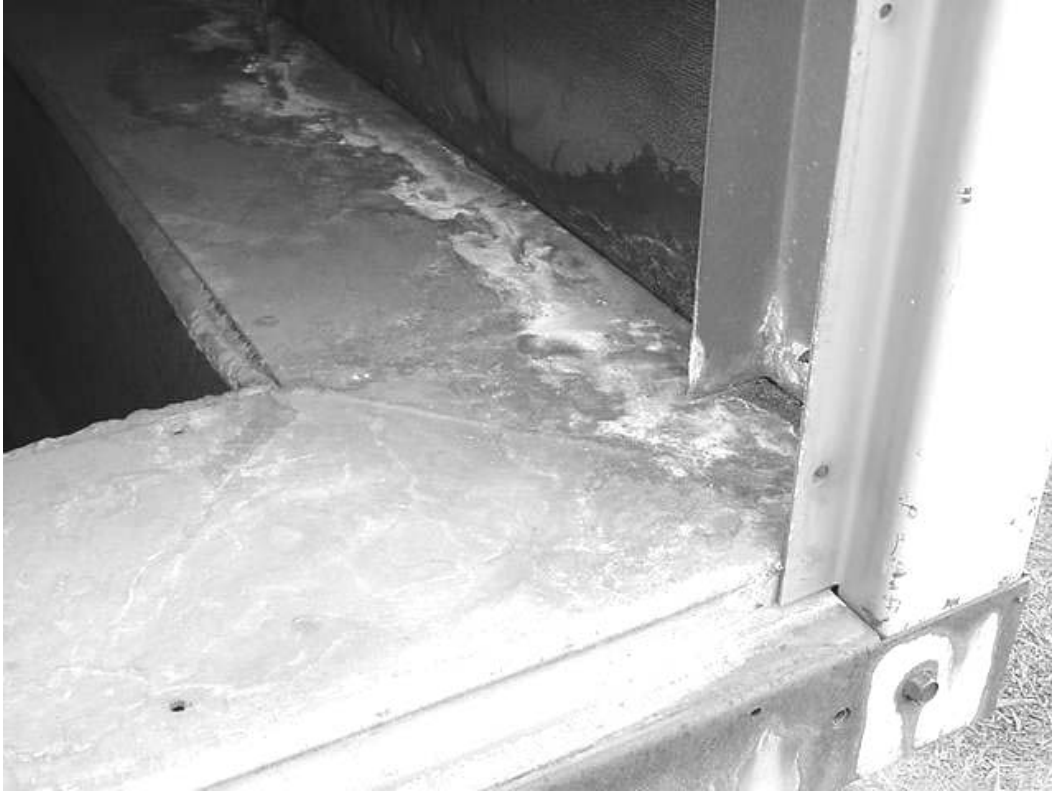
**Picture 16**

BEHA staff opened an AHU access panel and noted residue from what appeared to be pooling water (see Picture 16). The water stains on the interior of the unit can indicate: 1) that the panels were not fastened securely, 2) that the watertight integrity of the unit has been breached, or 3) that condensation is building up inside the unit. If the integrity of the case is breached, uncontrollable amounts of outdoor air, humidity and moisture can penetrate into the AHU, resulting in damage to machinery and creating conditions conducive to mold growth.

**Water Stains inside AHU**

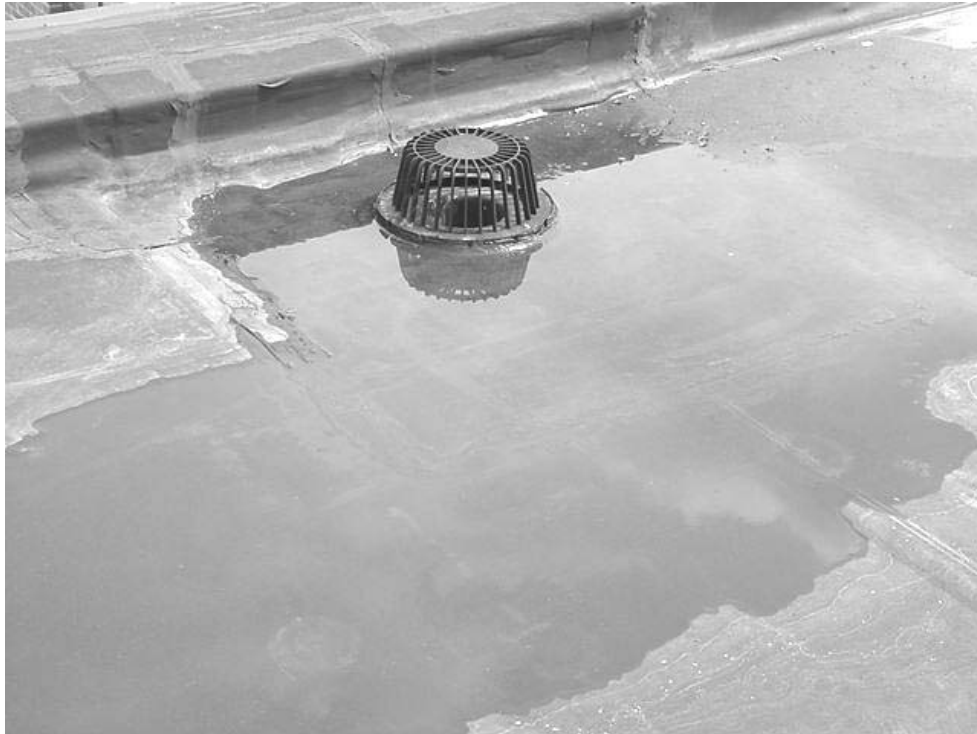
**Picture 17**

Pooling water was observed on the roof (see Picture 17). The freezing and thawing of water during winter months can lead to roof leaks and subsequent water penetration into the interior of the building. In addition, stagnant pools of water can serve as a breeding ground for mosquitoes.

**Pooling Water on Roof, Note Roof Drain**

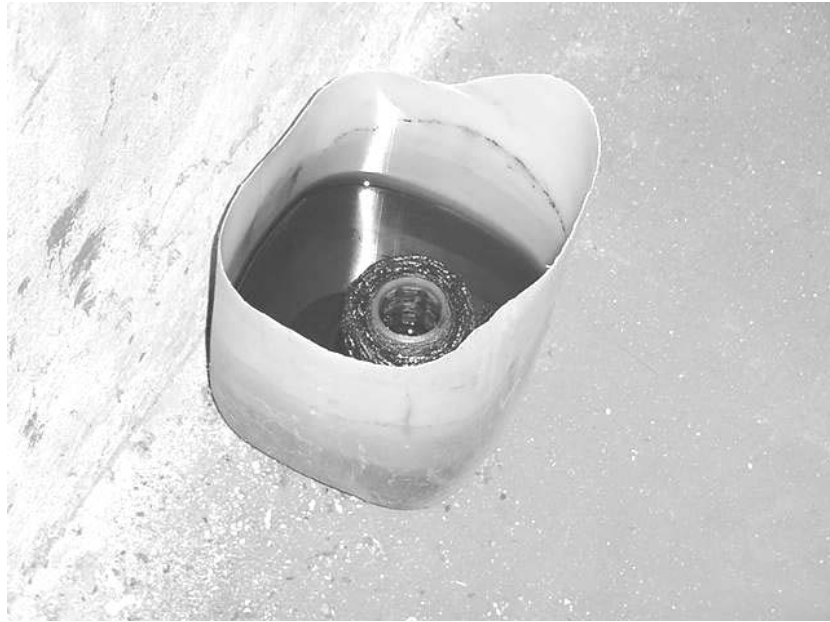
**Picture 18**

Located in the basement is the fuel tank and oil burner. A petroleum odor was noted in the basement. The most likely source appeared to be an open container of oil found on the floor against the basement wall (see Picture 18). Spaces were noted around

**Open Container of Oil in Basement**
